Transport
Canada

Issue 1/2013

Canadian Aviation Service Difficulty Reports

TP 6980E
(1/2013)

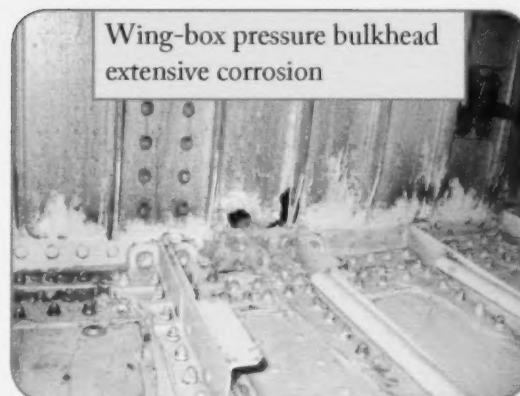
During a standard maintenance inspection check, extensive corrosion was found at forward wing-box bulkhead frame 39. The corrosion had perforated the pressure structure between stringers 55 and 54 left-hand side below waterline z-2557.

The standard inspection interval of this area is set at a 5 year interval where this aeroplane was last inspected on March of 2011. Depending on the aeroplanes operating environment and upon the operators' discretion, this interval can be reduced to accommodate possible discrepant findings as seen with this service difficulty. ✖

Wing-box pressure bulkhead
extensive corrosion

The bulkhead was repaired through the guidance of an Airbus Repair Approval Sheet (RAS) and made serviceable.

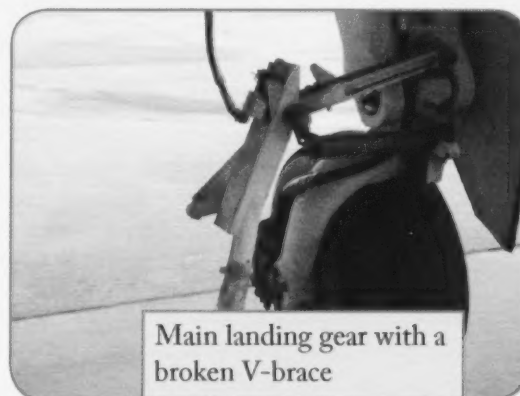
Following a landing, it was discovered that the left hand main landing gear V-brace was separated from the gear actuator point. Had the aeroplane taxied any further, the landing gear would have collapsed. A precautionary visual inspection on the right hand landing gear also revealed that the right hand V-Brace was cracked.

A detailed inspection using the magnetic particle inspection (MPI) technique on another aeroplane in their fleet found both the right hand & left hand V-braces to be cracked.

Main landing gear with a
broken V-brace

Beechcraft Service Bulletin (SB) 2361 recommends that should fatigue cracks be found on the main landing gear "A" Frame assemblies, then to install subject part number 105-8100-75 & 76. This should further support the strength of the attachment bracket for the hydraulic actuator connection.

Federal Aviation Authority (FAA) Airworthiness Directive 97-06-10 mandates SB 2361 to inspect the "A" Frame assemblies using both visual and dye penetrant methods but not MPI methods. The FAA has been advised accordingly. ✖

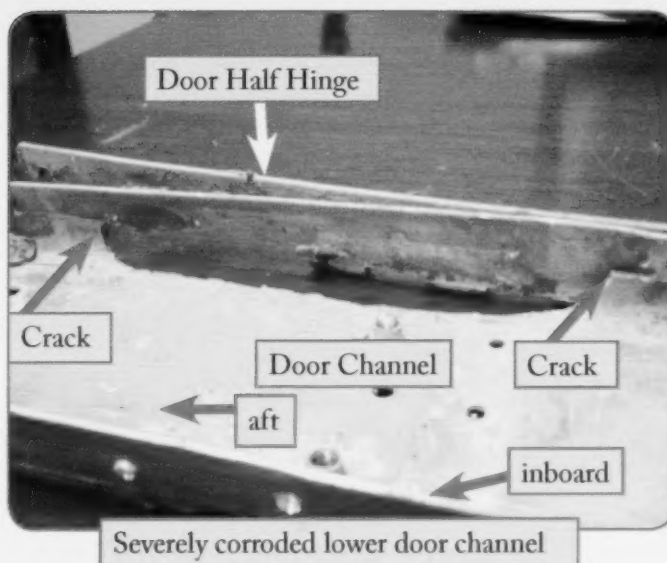
During servicing for the next flight, it was noted that the main cabin door lower step would move when stepped upon. Further investigation found the lower door channel had a 15.24 cm (6 inches) crack and the door side half hinge was broken 5.08 cm (2 inches) from the aft end. The channel (part number (P/N) 50-430043-619) half hinge (P/N 50-430043-547) and hinge pin (P/N 50-430043-393) were replaced due to severe corrosion.

The main door and steps require continuous inspections due to consistent use from passengers and exposure to environmental contaminants that promote corrosion. In this case, it appears that this step had been in this deteriorated condition for some time. ✖

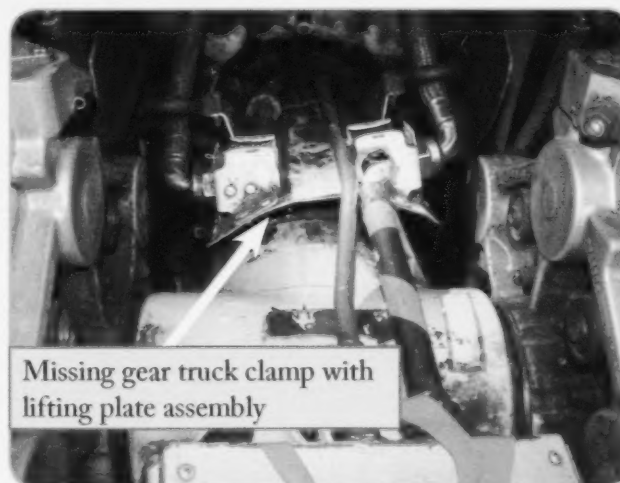
SDR # 20120126011

Main Landing Gear Anti-Skid Harness Incurred Damage

At the next maintenance opportunity, an investigation revealed that a clamp assembly was broken and had failed on the gear truck/bogie. The anti-skid wiring and conduits were also damaged. The damaged clamp, wiring and conduits were repaired making the aeroplane serviceable.

In order for this damage to occur, it appears that the plate assembly that the clamp secures was being pulled upwards (with the oleo at full extension) by the two flexible wiring conduits that travel up the gear strut.

Further investigations revealed that these two flexible conduits on the right-hand (R/H) gear were about 5 cm (2 inches) shorter than the ones on the opposite main landing gear causing the stress on the clamp.

The investigation is still ongoing into this apparent discrepancy of gear harness conduit length and is suspected to be a quality control issue from the supplier of the discrepant harnesses. In the meantime, Transport Canada Civil Aviation (TCCA) would like to advise all owners, operators and maintainers of this possible condition of clamp failure. ✖

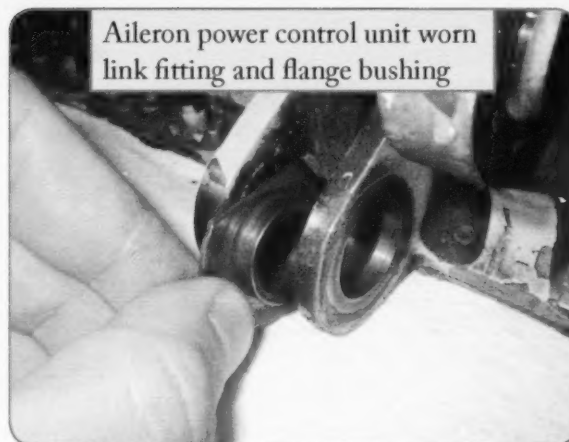
Worn Aileron Power Control Unit Attachment

The Aircraft Maintenance Engineer (AME) was performing a detailed inspection of the right-hand (R/H) aileron panel and surrounding area as per a planned task when he found the R/H aileron out-board power control unit (PCU) link attachment fitting on the aileron to be worn. The excessive wear occurred where the attachment bolt flange bushing is installed. The flange bushing was found loose and had migrated slightly and showed evidence of rotating within the link-fitting.

This condition can cause excessive backlash in the aileron system and damage to the PCU link and attachment fitting.

The aileron panel assembly was replaced with a serviceable unit and the aeroplane was returned to service following the heavy maintenance check.

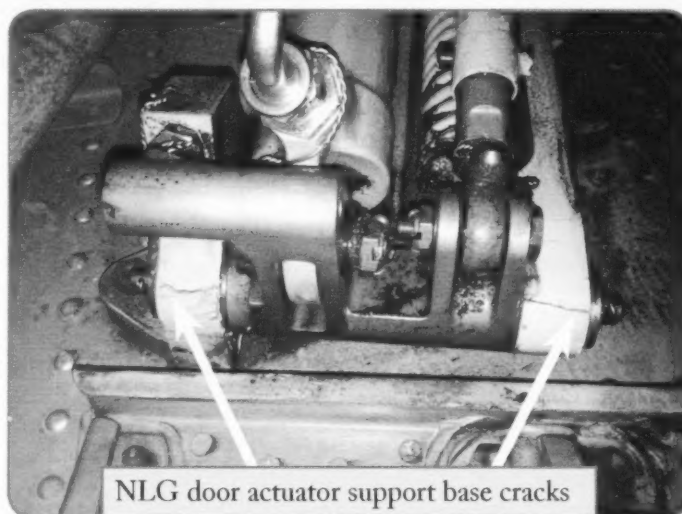
Nose Landing Gear Door Actuator Mount - Cracks

During a routine inspection, the maintenance engineer found cracks on both lower lugs of the nose landing gear (NLG) door actuator support base. The base is mounted on the right wall in the forward section of the nose wheel well.

Transport Canada Civil Aviation (TCCA) and the responsible type certificate holder, Bombardier, are working together in assessing this type of failure and its potential implications.

The base was replaced and the aeroplane was made serviceable.

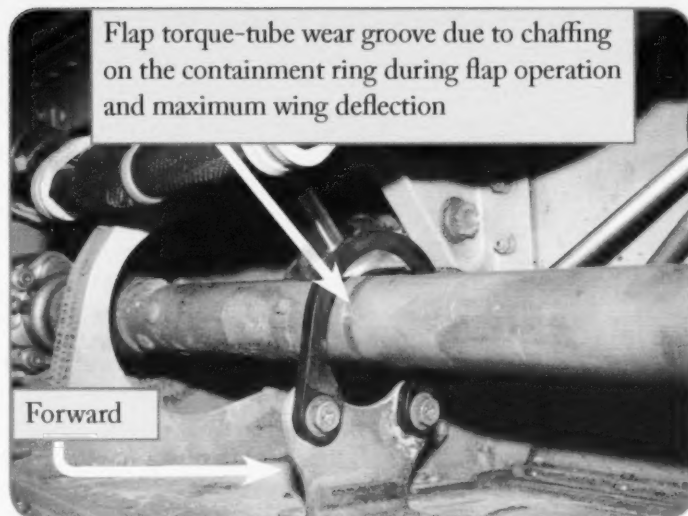
Flap Torque-Tube Chaffing

During a routine service check inspection, circumferential damage was found on the left-hand flap drive torque-tube at wing station (WS) 128 to WS 97. It was discovered that the torque-tube had been rubbing on the plastic containment ring during flap operation and maximum wing deflection, causing a chaffing condition.

The torque-tube was worn beyond limits and was replaced making the aeroplane serviceable.

Bombardier Service Bulletin (SB) 670BA-27-049 introduces a slightly larger containment ring to increase the clearance with the torque-tube and removes the possibility of a chaffing condition during flap operation and maximum wing deflection. ✖

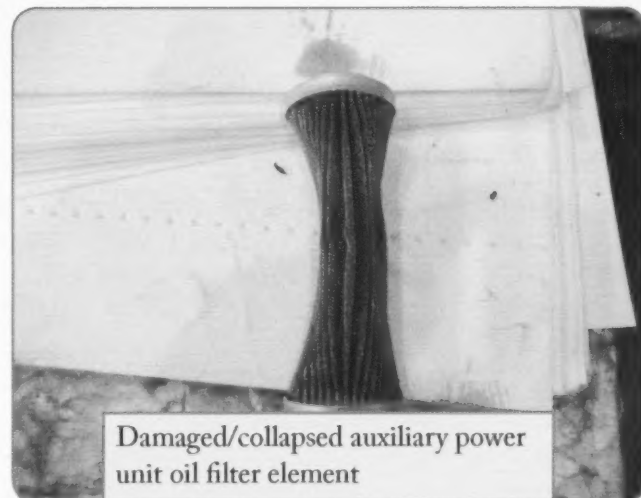
Auxiliary Power Unit Oil Filter Damaged

A collapsed filter was found during a scheduled replacement of the auxiliary power unit (APU) oil filter element per task 000-49-360-714 (2000 hours interval). The filter was replaced, leak checked and the aeroplane was released for service.

The filter had no trace of excessive contamination to cause the element to collapse where the likely cause was determined to be due to an incorrect installation.

It is important to note that for the correct installation of the APU oil filter and to prevent its inadvertent damage, the filter element must first be installed to the lube-module, followed by the oil filter bowl assembly. ✖

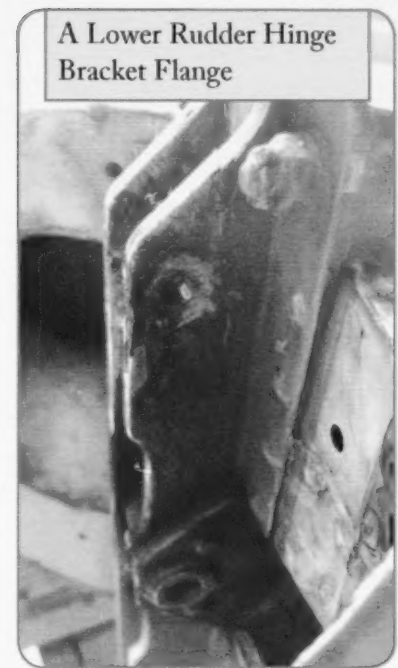
Rudder Hinge Assembly Flange - Crack

A visual inspection revealed a stress corrosion crack 6.35 cm (2.5 inches) in length, located on the lower rudder hinge bracket flange extension, adjacent to the rudder push pull rod end attachment point.

Possible contributing factors to stress corrosion cracks could be attributed to flight loads associated with floatplane operations, salt water environment and exposed rudder actuating rod end. ✖

The rudder was removed to facilitate the replacement of the bottom bracket.

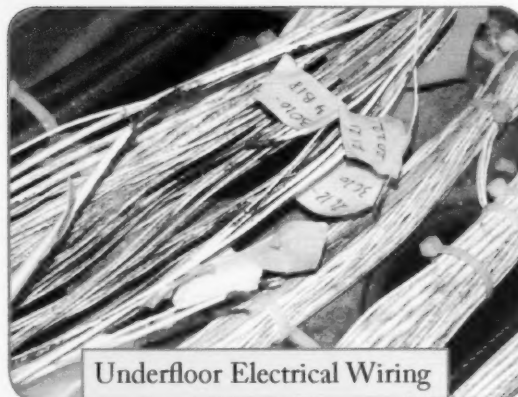
During taxi out for departure, the crew noticed a strong burning smell in the cabin and cockpit. The pilot elected to stop the aeroplane in the central deicing facility and the flight attendants proceeded to disembark all passengers.

During maintenance troubleshooting, several unusual defects were noted. The #2 cargo smoke detector failed to "test", the #1 standby pump "hot" caution light illuminated and the #1 bleed control circuit breaker "popped" whenever the switch was selected to "off". Further investigation revealed numerous electrical wires in the wiring channel located under the cabin floorboards on the left-hand side at passenger Row 1, were chafed/blackened and "shorted" to each other. The damaged wires were repaired, electrical circuits tested and aeroplane returned to service.

It is advisable that maintenance personnel be particularly mindful regarding the condition of electrical wiring, particularly in older model aeroplanes. ✂

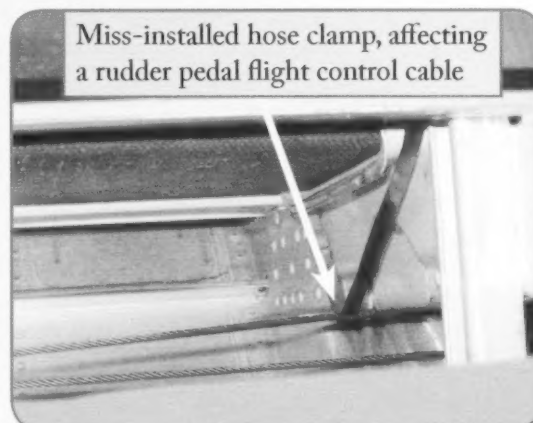
A visual inspection confirmed that a stainless steel hose clamp for an air-conditioning distribution duct was mistakenly secured around an adjacent rudder control cable.

Chaffing marks were found on the transverse floor beam channel and a repair was performed as per Structural Repair Manual (SRM) 53-00-5.

Miss-installed hose clamp, affecting a rudder pedal flight control cable

An obvious mistake from the installer where the lesson learnt and standard to take would be to always perform a complete visual inspection of the installed part and its surrounding area to ensure for its correct installation. ✂

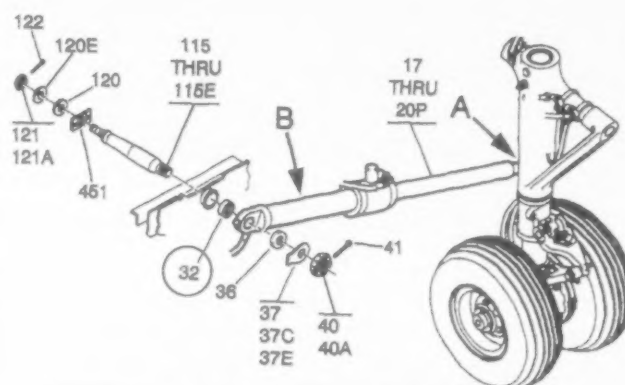
The conical spacer was discovered cracked when the left main landing gear (MLG) retract actuator was removed for access to address another problem. The right MLG was also found with the same cracked conical spacer.

The nature of the crack indicates it is being over-loaded on the conical surface resulting in the fracture.

Bombardier Learjet engineering have been advised of this event, including two others in the past 4 years. Learjet analysis has confirmed that the cracking of these spacers is due to stress corrosion and does not create a safety issue.

Cracked conical spacers, Item 32

Both of the conical spacers were replaced, making the aeroplane serviceable after the initial problem was corrected.

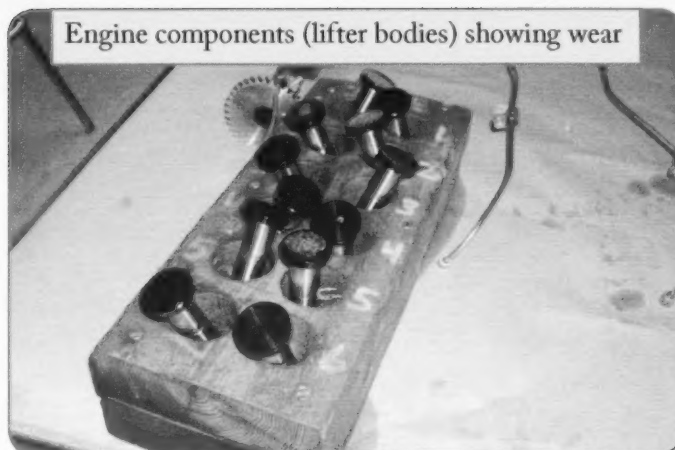
Engine Wear

Metal was found in the oil filter during a 50 hour inspection. Follow-up inspections were conducted in accordance with Lycoming Service Instruction-1492d. The aeroplane was ground run for 30 minutes - no metal found in filter.

The aeroplane was flown for one hour and the oil filter was again removed for inspection. Metal was again found in the filter and the engine was then removed for inspection and overhaul.

When an aeroplane engine shows signs of wear outside of what would be considered normal, questions must be asked as to the cause. If a reasonable explanation cannot determine the cause of the fault, teardown or overhaul is often the only choice.

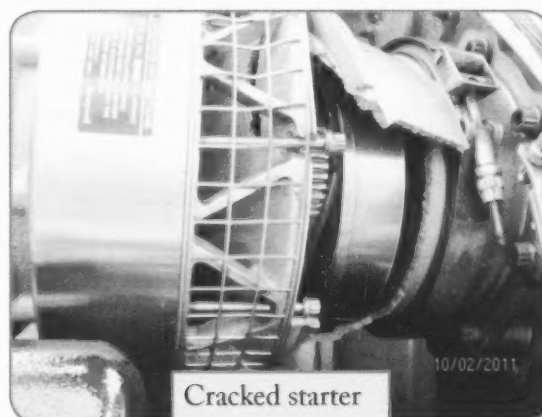
Cracked Starter Causing Oil Loss / Engine Shutdown

While en route, the crew noticed a low oil quantity indication of 2 quart for the #1 engine. The oil pressure and temperatures were reported to be normal for the next 40 minutes when the quantity dropped to zero and pressure dropped to minimum values. The low oil pressure warning for the number 1 engine annunciated. The flight crew shut down the number 1 engine and the aeroplane landed.

Maintenance found that the number 1 engine starter sustained significant fracture damage to the housing assembly. With the CFM56 shared oil with the starter it is suspected that this was the exit point for the engine oil. Using recorded data, it was confirmed that the oil pressure limitations were not exceeded. Maintenance actions and engine runs carried out as per the aircraft maintenance manual and the aeroplane was released for service.

The exact cause of the failure is not known, however the overhaul report stated that the 'Failed gear housing allowed oil loss, ultimately causing an in flight shut down. ✖

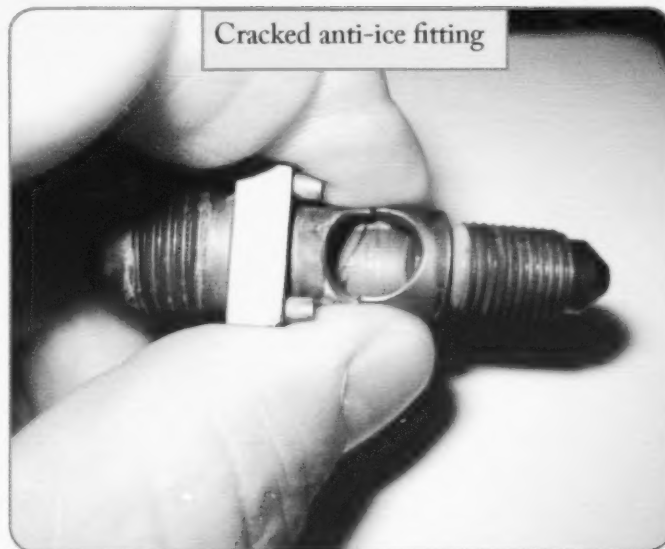
Cracked Anti-Ice Fitting Affecting Engine Performance

The engine would not develop full power at altitude. Maintenance discovered that a fitting on the anti-ice shield was cracked, affecting the p2t2 sensor. This caused the single red-line (SRL) computer to control the exhaust gas temperature (EGT) incorrectly. The fitting was replaced and the aeroplane was returned to service. No further incidents were reported by flight crew.

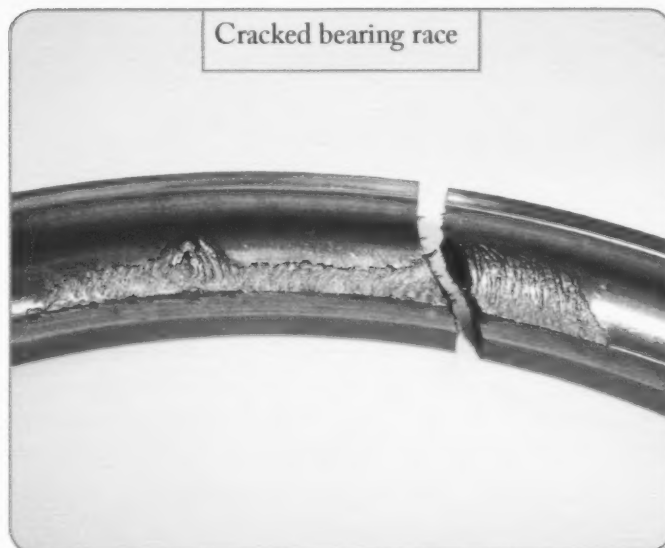
SDR # 20111122004

Broken Propeller Bearing Race

During the replacement of the aeroplane's left propeller actuator, the engineer noticed that the #1 blade outer race located inside the propeller hub was broken. A visual inspection of the #1 blade outer race revealed plating missing on the lower section of the race near the fracture point and bearing marks along the race. Fragments of metal were also observed at the fracture point, standing straight as if the race was magnetized. The remaining blades were removed and the #4 blade outer race was found with a small area of plating missing and bearing marks along the race. The propeller hub is currently being replaced. Similar damages were reported a few weeks previously on the right propeller of the same aeroplane. The hub assembly has been shipped to a repair station for a detailed inspection/evaluation.

It is important to conduct area inspections when carrying out line maintenance tasks especially with high time components. ✂

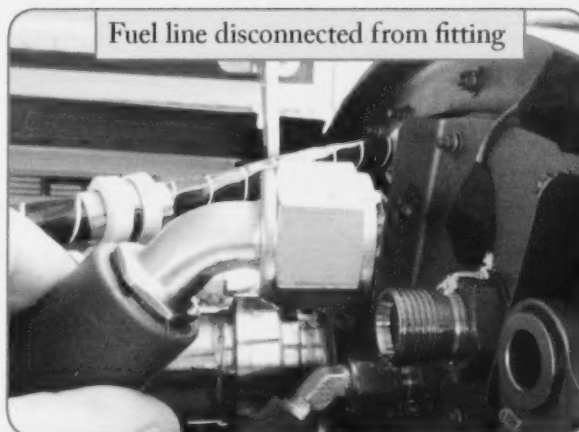
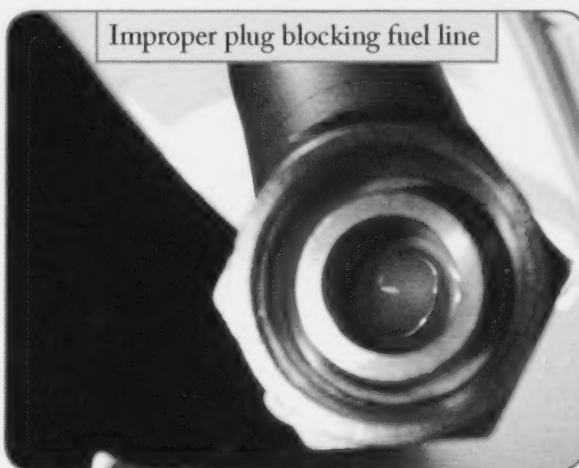
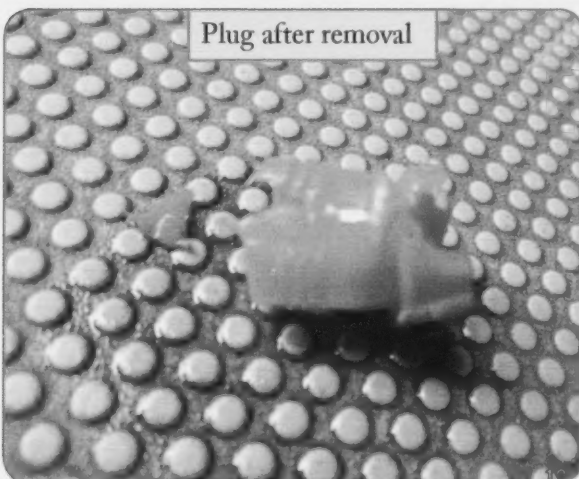
Improper Use Of Tooling Causing In Flight Shutdown

Pilot reports that after takeoff at approx 1200 Feet, during clean up of the flight deck configuration, the #2 engine fuel auxiliary pump was selected off. Approximately 5 to 10 seconds after the pump was selected off, the engine began to surge with an associated fuel pressure master caution light and then the engine failed. The pilot returned to base.

Maintenance found a protective cap inside a flex line going to the Fuel Metering Unit.

Improper use of various tooling including protective caps can cause many problems such as blocked pitot/static ports, weight on wheel configuration problems as well as damaged structure or components. Instructions for correct tool use must be followed at all times including ensuring that the tool is in proper condition. Any warning devices or flags to remind maintainers to remove the tool prior to maintenance release must also be in place and intact. ✖

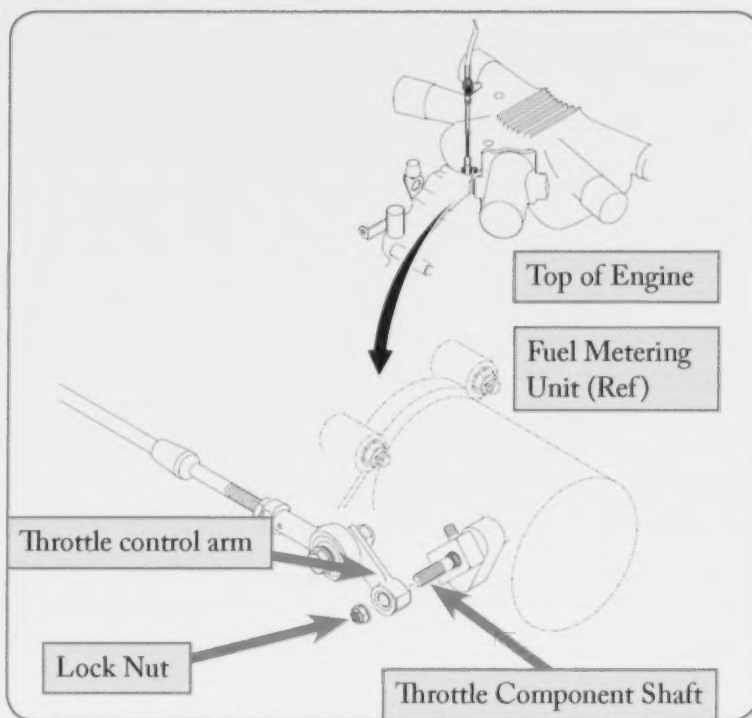
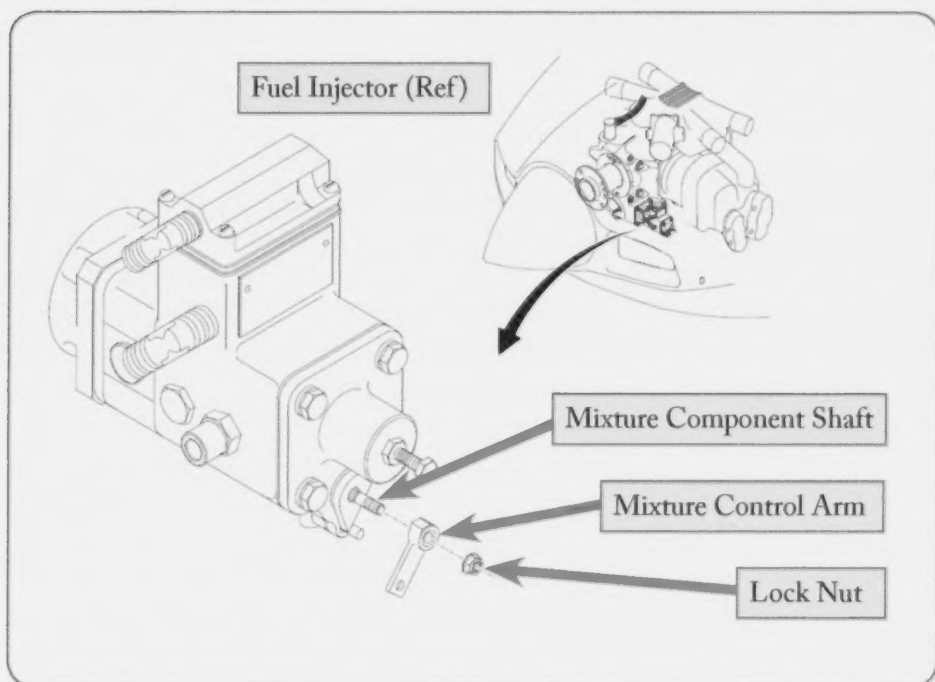
Engine Control Service Information Letter

On final approach, the engine would not respond to throttle input. The engine was shut-down with the mixture lever cut-off and the aeroplane landed short of the paved runway in the grass. There was no injury to the crew or passengers and no physical damage to the aeroplane. A post-flight inspection revealed damage to the splines on throttle body lever-to-cable hook-up.

Diamond Aircraft has released Service Information Letter 20C1-006 which describes inspection and maintenance of both the throttle and mixture control arms. It is important that operators inspect their aeroplanes in accordance with these instructions. ✖
